MACHINE METROLOGY FOR OPTIMAL PERFORMANCE

The machining time for complex workpieces such as turbine blades, impellers, medical prostheses and complex machine frames, as manufactured on 5-axis machine tools, can be very long, typically many hours. The machine's thermal stability is critical for meeting geometrical tolerances and must remain below a certain value. This article presents a fast and accurate method for the dynamic 3D measurement of thermal stability and features a case study describing the use of a non-contact wireless probe.

GUIDO FLORUSSEN, HENNY SPAAN AND THERESA SPAAN-BURKE

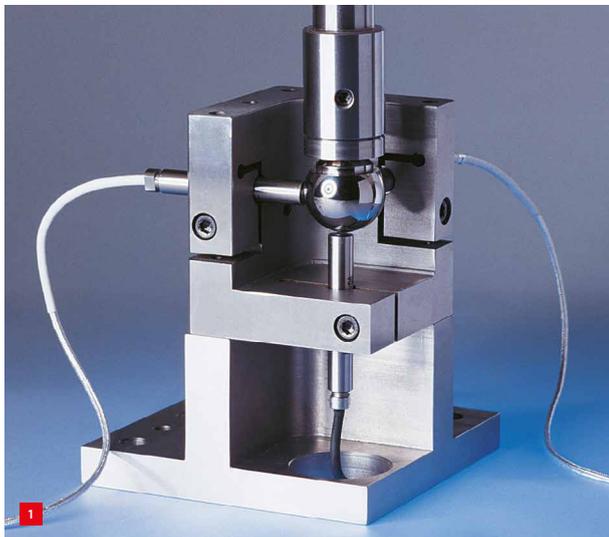
Set-up of a classic thermal distortion test using three capacitance sensors.

tool, a high-precision masterball (roundness error < 25 nm) is placed in the spindle and three capacitance sensors are placed in a probe-nest, mounted rigidly on the machine's workpiece table (Figure 1). The spindle is commanded to execute a constant spindle speed (or a spectrum with variations in speed and interval duration) and the relative displacement of the masterball is recorded in X-, Y- and Z-direction. When five sensors are used in combination with a dual masterball or cylinder, the tilt error around X and Y can also be measured. This ISO test assumes that the dominant heat source is the spindle and ignores heat from the cutting process. During finishing, where the precision is required, cutting depths and forces are typically small. When applying such a test, it is best to simulate the machine's normal operation conditions as well as possible.

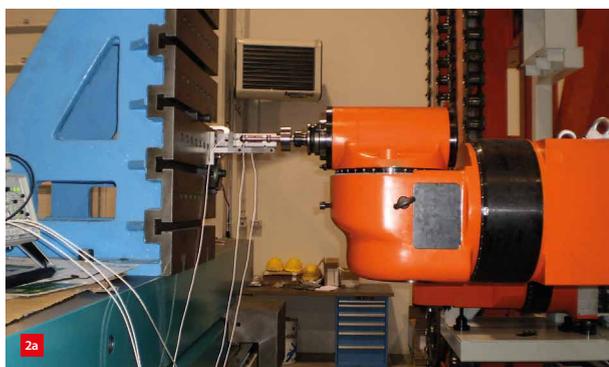
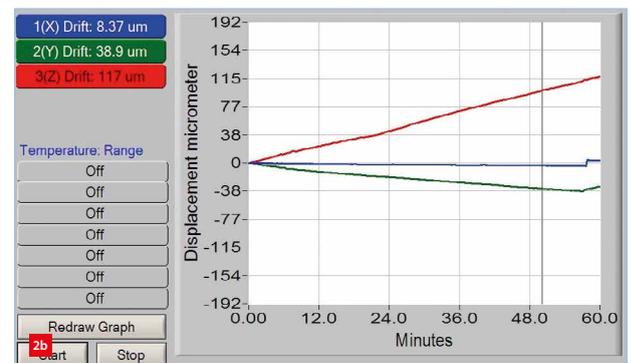
Thermal distortion test on a 'poor' example of a large machine tool.
 (a) Set-up, showing dual masterball and probe nest; X-axis is perpendicular to drawing plane, Y-axis is vertical, Z-axis runs into the spindle.
 (b) Thermal distortion (displacement between spindle and table) in X (blue line), Y (green) and Z (red) versus time. Drift (within one hour) in X, Y and Z is 8.37, 38.9 and 117 μm , respectively.

Figure 2 shows a 'poor' example of a large machine tool: the spindle is rotating at its maximum speed of 2,500 rpm and the relative displacement between spindle and table is measured. In this example the thermally induced drift is largest in Z-direction and exceeds 100 μm in less than one hour. This test had even to be stopped to avoid contact between the masterball and the sensor. No thermal correction methods have been used in this machine tool. Figure 3 displays the measured drift of a milling machine used for cutting turbine blades where the spindle is running

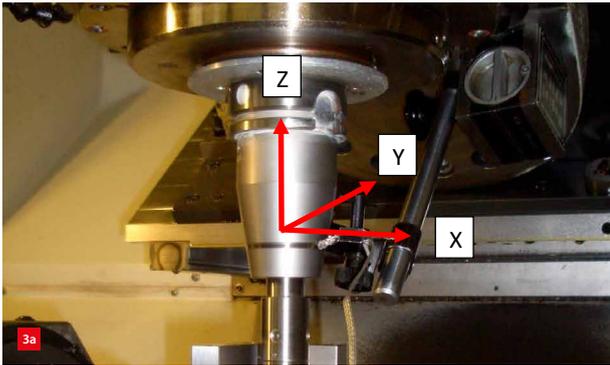
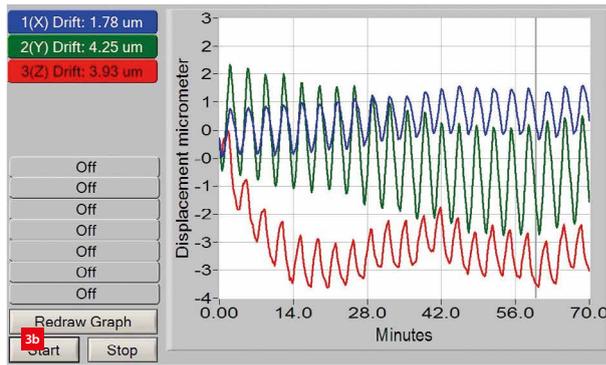
Thermal distortion test for a milling machine with active cooling.
 (a) Set-up, showing orientation of the X-, Y- and Z-axis.

(b) Result (displacement between spindle and table) for 70 minutes, with spindle rotating at 10,000 rpm. Thermal drift is less than 4.25 μm .

at 10,000 rpm for 70 minutes. This machine cools its spindle within 1 °C (wave period is about 3.5 minute) and shows a good thermal stability, with a drift of less than 4.25 μm . The periodic impact of the cooling is clearly visible.

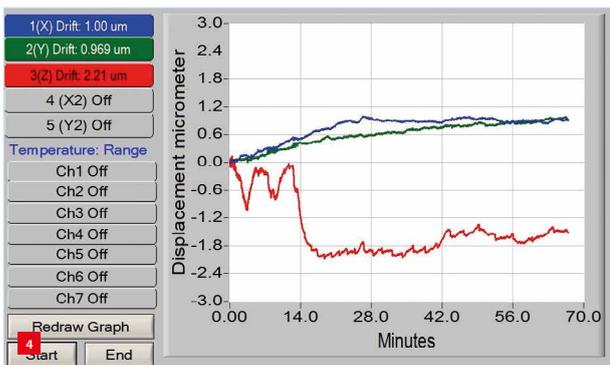
Thermal distortion test result (displacement between spindle and table) for a 'best-in-class' milling machine at 42,000 rpm. Drift in X (blue), Y (green) and Z (red) is shown over 70 minutes.

Figure 4 presents an even better example. This can be classified as representative of 'best-in-class' machines on the market. Here a milling machine, used for manufacturing 'smooth-surface moulds', is commanded to execute 42,000 rpm and the measured thermal distortions are recorded. The measured displacement is less than 2.2 μm in Z-direction, and in X- and Y-direction the thermally induced drift is even less than 1 μm . Machines with such good stability are rare and very expensive (> 1 M€) and typically employ multiple thermal correction techniques combined.

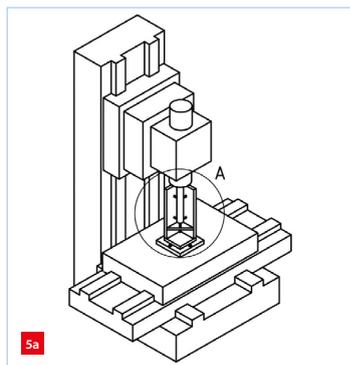
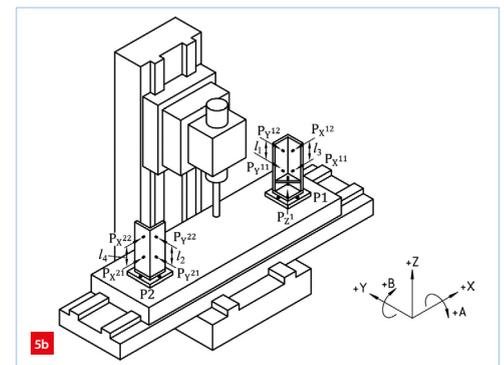
Schematic drawings of ISO 10791-10.
 (a) Classic test set-up.

(b) New set-up for which a linear axis is moved between P1 and P2 for a period of time.

In the tests above, only the spindle is active and the axes do not move. In ISO 10791-10, "Test conditions for machining centres – Part 10: Evaluation of thermal distortions", [2] additional tests are implemented to include moving axes, see Figure 5. The ISO 230 series covers the test conditions for accuracy measurement of (conventional) machine tools where the ISO 10791 series apply to machining centres, which can execute multiple machining operations; 5-axis machine tools would typically class as machining centres. The approach to thermal tests is the same in both standards.

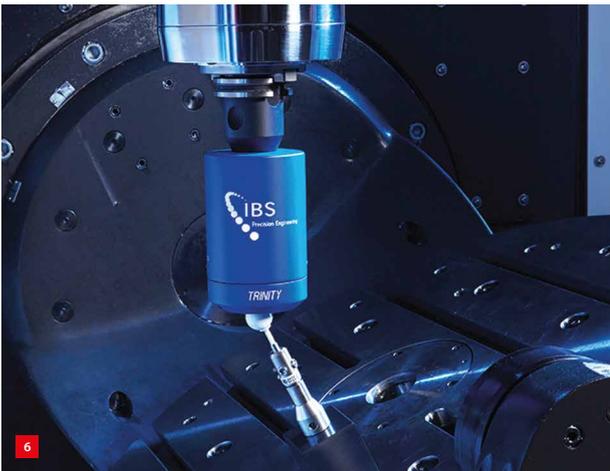
Rotary Inspector set-up: 3D probe in spindle, masterball on the table.

5-Axis machine tools incorporate linear X-, Y- and Z-drives combined with two rotary tables to allow rotation about two of these axes. Classic thermal distortion tests cannot determine changes in pivot line position and squareness of the rotary axes, relevant for all 5-axis machine tools. IBS Precision Engineering has developed a measurement system dedicated for 5-axis machine tools named Rotary Inspector. The measurement system consists of a Trinity wireless measuring head, comprising three displacement sensors for non-contact measurement, and a precision masterball. The measuring head (probe) is mounted in the spindle and the masterball is placed in a fixed position on the table (Figure 6).

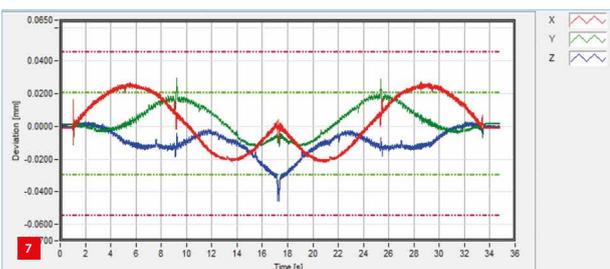
Displacement (deviation) in X, Y and Z between Trinity measuring head (representing cutting tool) and masterball (representing workpiece) during synchronised 5-axis motion of linear axes and rotation table (see Table 1).

Figure 7 and Table 1 present the results of an example measurement. The 5-axis test result (Figure 7) shows the amplitude of the X-, Y- and Z-direction displacement between the masterball and the probe during the test motion. Where the position of the masterball is determined by the rotary axes and that of the probe by the linear axes. As the masterball represents the contact point of the workpiece and the probe the end of the cutting tool, the smaller these deviations are, the better the machine's precision.

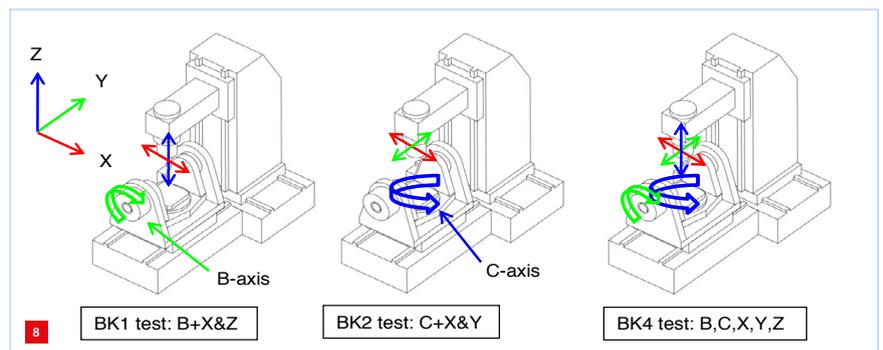
Schematics of kinematic tests on a 5-axis machine tool with B- and C-axis at the table (see Table 2).

The Rotary Inspector system was mounted on a 5-axis machine tool having a B- and a C-axis present at the table. The machine was commanded to continuously execute the corresponding NC file in a loop, moving all axes, see

Figure 8 and Table 1. Feed rate was set to 1,500 mm/min. In Table 3 the results are compared between 'cold start', and after 5 and 30 minutes of 'heat-up by moving axes'. During the 30 minutes heat-up the B-axis has moved -5.0 µm in X-direction and -11.2 µm in Z-direction. The squareness of the B-axis pivot line to the linear axis was also determined, see Table 4. The rotation of the B-axis pivot line can be neglected as this is less than 1 millidegree.

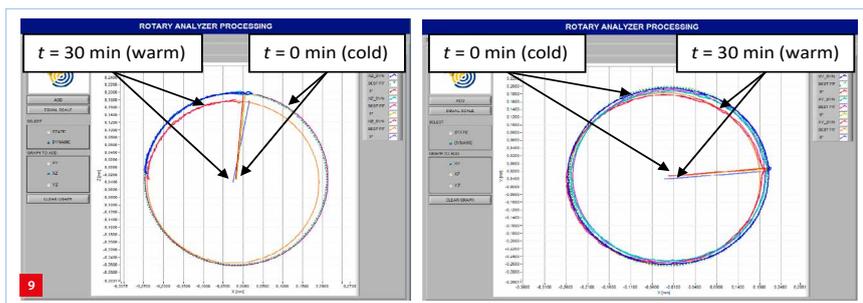
Analysis results for the DMU machine.

- (a) B-axis (XZ-plane).
- (b) C-axis (XY-plane).

circles in the XZ-plane for the B-axis (see Figure 9a) and in the XY-plane for the C-axis (see Figure 9b). As the machine was commanded to execute a relative circle with 0.2 mm radius (between a rotary axis and the circular path of two linear axes), measurement data is distributed on a circle.

A perfect machine would show a concentric circle with 0.2 mm radius. Any deviations are representative of errors in the alignment of the rotary axis path to the linear axes or vice versa. The B-axis was measured with the BK1 test (see Table 2 and Figure 8); the measurement was performed twice, at $t = 0$ and $t = 30$ min. The C-axis was measured with the BK2 test (also at $t = 0$ and $t = 30$ min). Due to the drift of the total machine, the centre point of both the B- and C-axis in Figure 9 has moved. This has resulted in a different circular path as shown in both graphs; blue is the circular path for $t = 0$ (cold machine) and red is the path for $t = 30$ min (warm machine).
